# Stream Barrier Inventory

Wells National Estuarine Research Reserve

2013

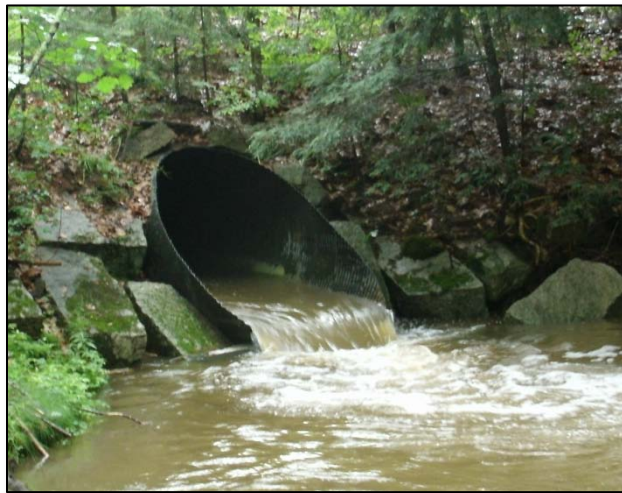
## Limerick Road, Arundel

**Site ID:** 4042  
**Road:** Limerick Road  
**Stream:** Duck Brook  
**Ownership:** Town of Arundel  
**Crossing Structure:** Round Culvert  
**Barrier Status:** Barrier, Perched Outlet

Factors creating a barrier at this crossing include a perched outlet with a 0.13 meter drop, an inlet drop, and increased water velocity due to narrowing of the stream width through the crossing,

This crossing represents the only significant barrier between the Gulf of Maine and Davis Pond (4.3 acres). Ideally, it should be replaced with one that is set below stream grade and exceeds the normal channel width to eliminate the drops and reduce water velocity.

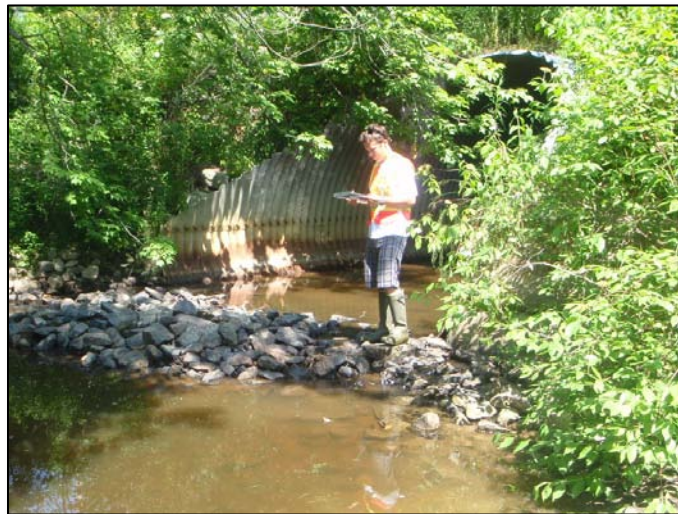
## Sinnott Road, Arundel

**Site ID:** 4015  
**Road:** Sinnott Road  
**Stream:** Goff Mill Brook  
**Ownership:** Town of Arundel  
**Crossing Structure:** Pipe Arch Culve  
**Barrier Status:** Barrier, Perched Outlet, Blocked Outlet

Factors that contribute this barrier include a perched outlet with a 0.1 meter drop, and rip rap partially blocking the outlet.

Rip rap should be removed from the outlet by hand. If replacement of the crossing structure is not feasible, the outlet of the culvert should be modified by bending it if possible to reduce or eliminate the drop.

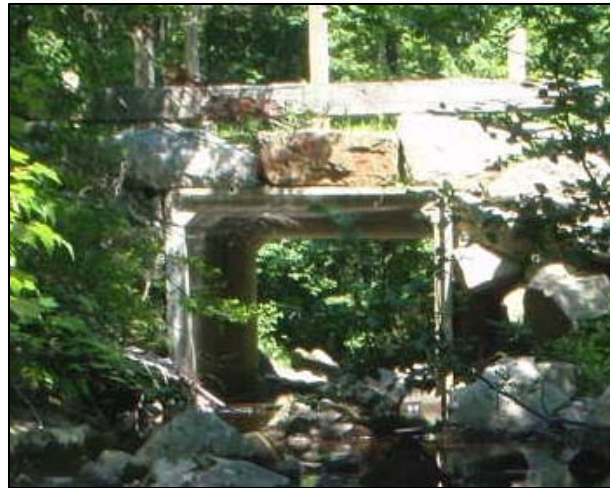
## Whispering Fern Way, Arundel

**Barrier Status:** Barrier, Perched Outlet

Factors that contribute this barrier include a perched outlet with a 0.03 meter drop and increased water velocity due to narrowing of the stream channel through the structure.

The structure should be replaced with one that is set at or below stream grade and exceeds normal channel width to eliminate the drop and decrease water velocity.

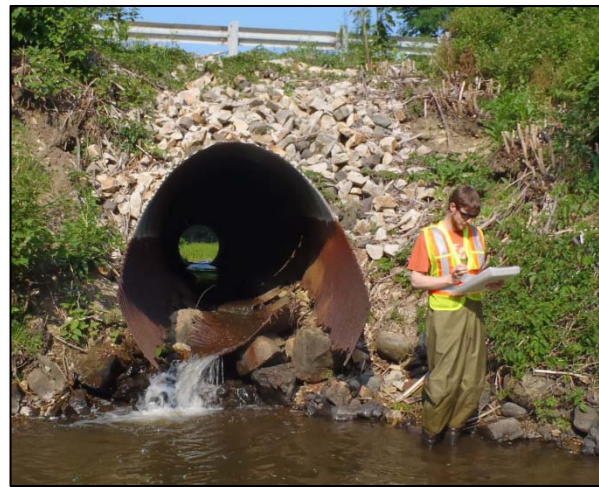
## Route 101, Eliot

**Site ID:** 11730  
**Road:** Route 101  
**Stream:** Shorey's Brook  
**Ownership:** Town of Eliot  
**Crossing Structure:** Pipe Arch Culve  
**Barrier Status:** Barrier, Perched Outlet

Factors that contribute this barrier include a perched outlet with a 0.49 meter drop and increased water velocity due to narrowing of the stream channel through the structure.

Replacement of this crossing is under consideration by Maine DOT due to ongoing failure of the culvert. Ideally, the culvert will be replaced with a bridge, which will eliminate the drop and reduce water velocity.

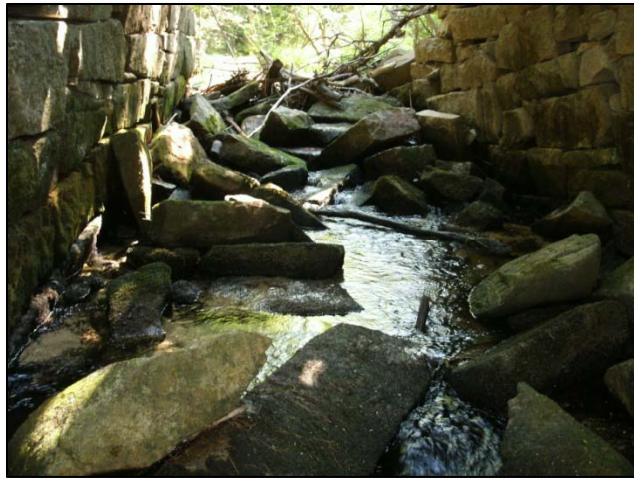
## Abandoned bridge near Wire Road, Kennebunk

**Barrier Status:** Barrier, Blocked

This crossing appears to be an abandoned road or railway near Wire Road. It is located on a parcel owned by the KKW Water District. The stone bridge has partially collapsed and rocks and debris block the entire crossing. The crossing also restricts the channel, which would increase water velocity if the crossing were not also blocked.

This crossing constitutes a significant barrier on the main stem of Branch Brook. Debris and collapsed stones should be removed from the stream channel, and ideally the bridge should be completely or partially removed to restore full channel width and decrease high water velocity.

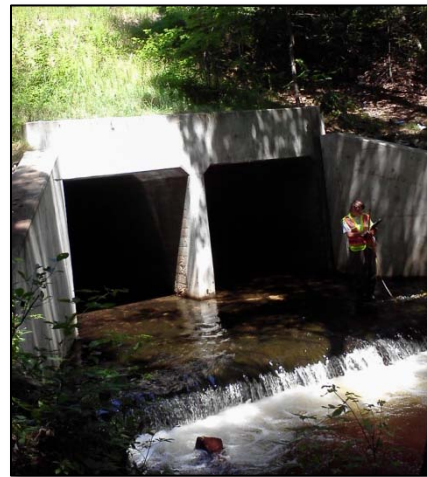
## Route 9A, Kennebunk

**Barrier Status:** Barrier, Perched Outlet

Factors creating a barrier at this crossing include a perched outlet with a 0.27 meter drop and increased water velocity due to narrowing of the stream width through the crossing. This crossing includes a concrete pad at the outlet that creates a perch.

Due to the size and design of this structure, it seems unlikely that it will be replaced. However, modifications could be made to the outlet to eliminate the drop, and interior structures could be installed to reduce water velocity.

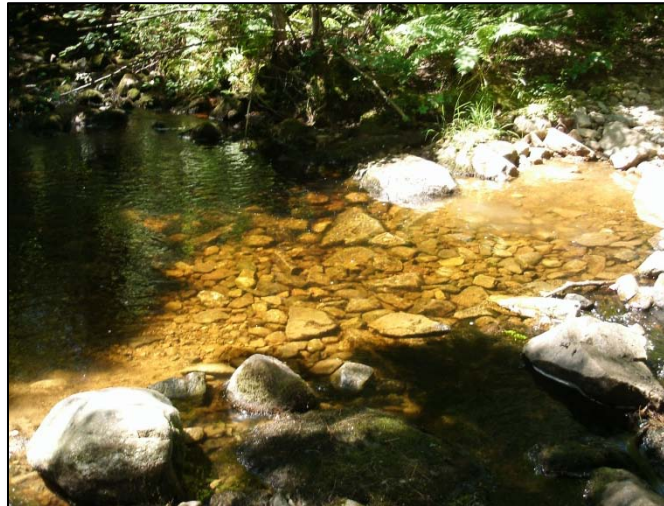
## ATV trail off of Route 111, Lyman

**Barrier Status:** Moderate Barrier  
Blocked Outlet

Factors creating a barrier at this crossing include rip rap that has been placed in the stream, and rip rap and other debris, possibly from an old bridge, that partially block the outlet of the ford.

This crossing could be easily improved by installing a suitable alternative crossing structure, such as a timber frame bridge, as well as removing debris and rip rap from the outlet and stream channel.

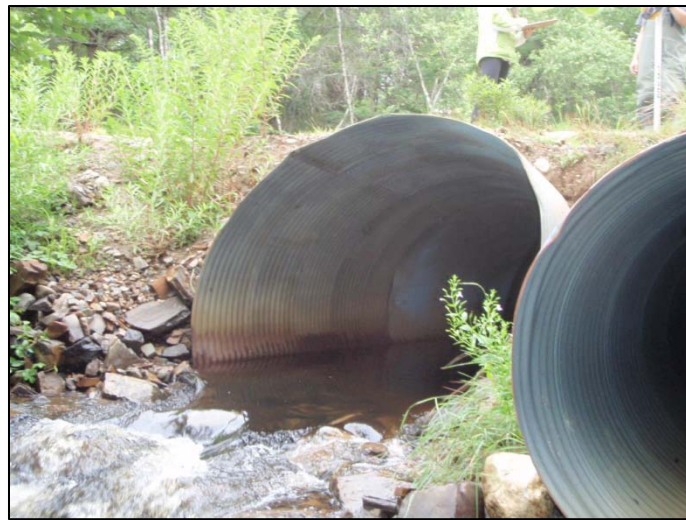
## Cripple Creek Drive, Lyman

**Site ID:** 4050  
**Road:** Cripple Creek Drive  
**Stream:** Carlisle Brook  
**Ownership:** Private  
**Crossing Structure:** Round Culvert  
**Barrier Status:** Barrier, Outlet Perched Above Cascade

Factors that contribute to this barrier include an outlet perched above a cascade created by rip rap, and increased water velocity due to narrowing of the stream width through the crossing. There is also a secondary round culvert at this crossing, set at a higher elevation and also perched.

Both of these culverts should be replaced with a single structure that is at or below stream grade and exceeds the normal channel width to eliminate the drop and decrease water velocity.

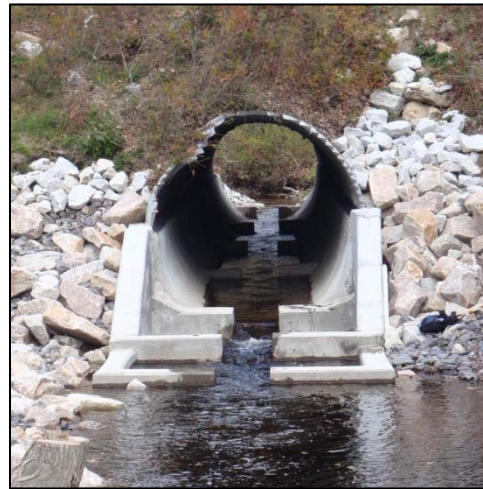
## Route 111, Lyman

**Site ID:** 4060  
**Road:** Route 11  
**Stream:** Lord's Brook  
**Ownership:** Maine DOT  
**Crossing Structure:** Pipe Arch Culvert  
**Barrier Status:** Barrier, Perched Outlet  
**Barrier Description:**

Factors creating a barrier at this crossing include a perched outlet with a 0.17 meter drop, an inlet drop, and increased water velocity due to narrowing of the stream width through the crossing. It appears that this crossing has been modified to include weirs at the outlet and within the structure in an attempt to reduce water velocity through the crossing, which has created a large scour pool. The culvert appears to have been perched previously, and the modifications have increased the outlet drop by several inches.

Ideally, this crossing should be replaced with one that is at or below stream grade and exceeds the normal channel width to eliminate the drop and reduce water velocity.

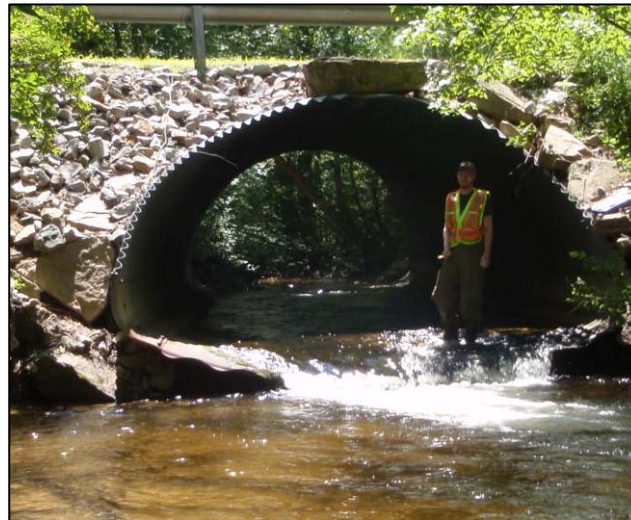
## Day Hill Road, Wells

**Site ID:** 11665  
**Road:** Day Hill Road  
**Stream:** Branch Brook  
**Ownership:** Town of Wells  
**Crossing Structure:** Pipe Arch Culvert  
**Barrier Status:** Barrier, Perched Outlet

Factors that contribute this barrier include a perched outlet with a 0.25 meter drop, and increased water velocity due to narrowing of the stream width through the crossing. The outlet of this structure has been bent so that the outlet drop is not completely vertical.

This structure should be replaced with one that is at or below stream grade and exceeds the normal channel width to eliminate the drop and decrease water velocity.
