# Stream Barrier Survey Report

Wells National Estuarine Research Reserve

April 8<sup>th</sup>, 2013

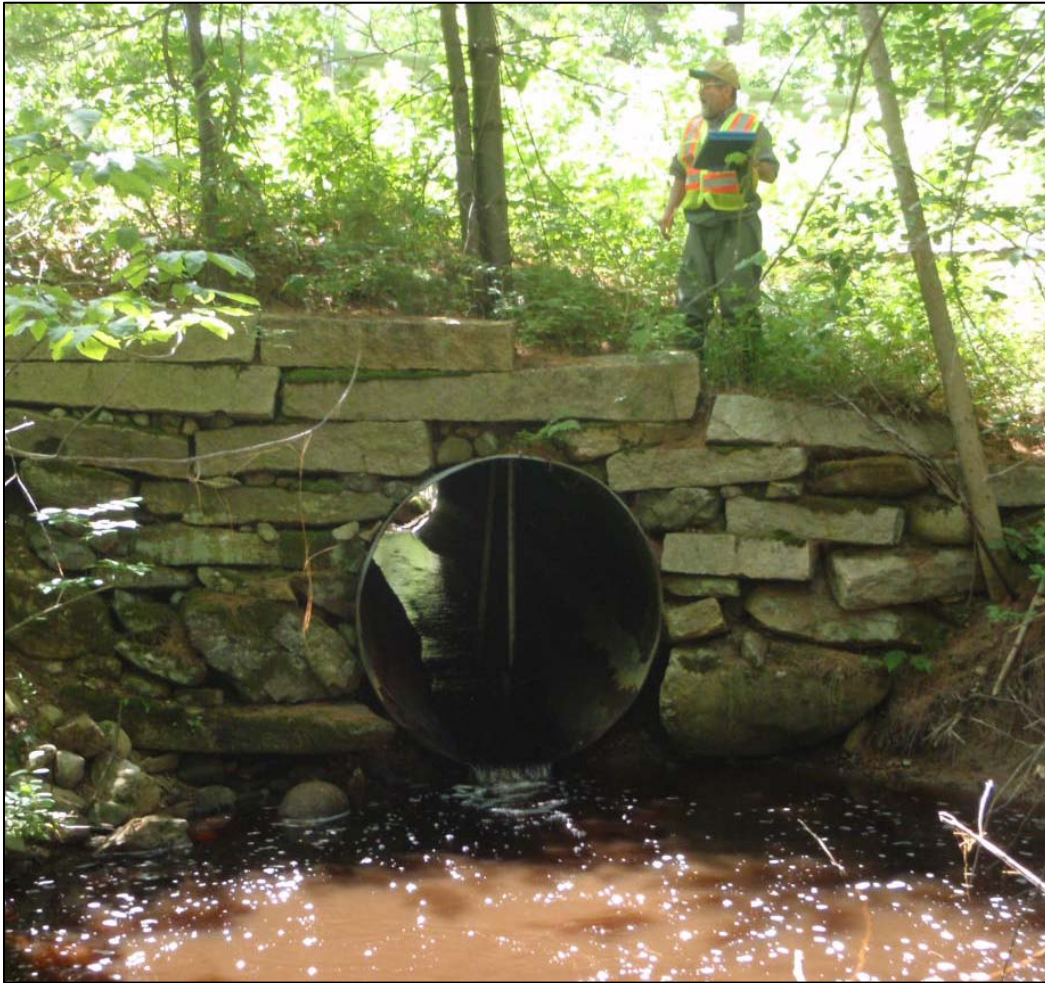
### *Cover Photograph*

Trout Unlimited volunteer Steve Heinz surveys a culvert at the crossing of Day Hill Rd. and an unnamed tributary to Branch Brook in Wells, ME.

Priority site 11665 is a pipe arch culvert at the crossing of Branch Brook and Day Hill Road in Wells. This crossing is maintained by the Town of Wells. This crossing is a priority due to its location on the mainstem of the brook. The outlet of this crossing is perched 0.25 m above a large scour pool. Higher velocity water inhibits the movement of smaller fish species and other weaker swimmers. Removal of this barrier would open

upstream access to approximately 5 miles of upstream stream habitat for resident fish. Benefit from crossing replacement at this site would have limited benefit until passage is achieved at site 11664 and the KKWWD dam.

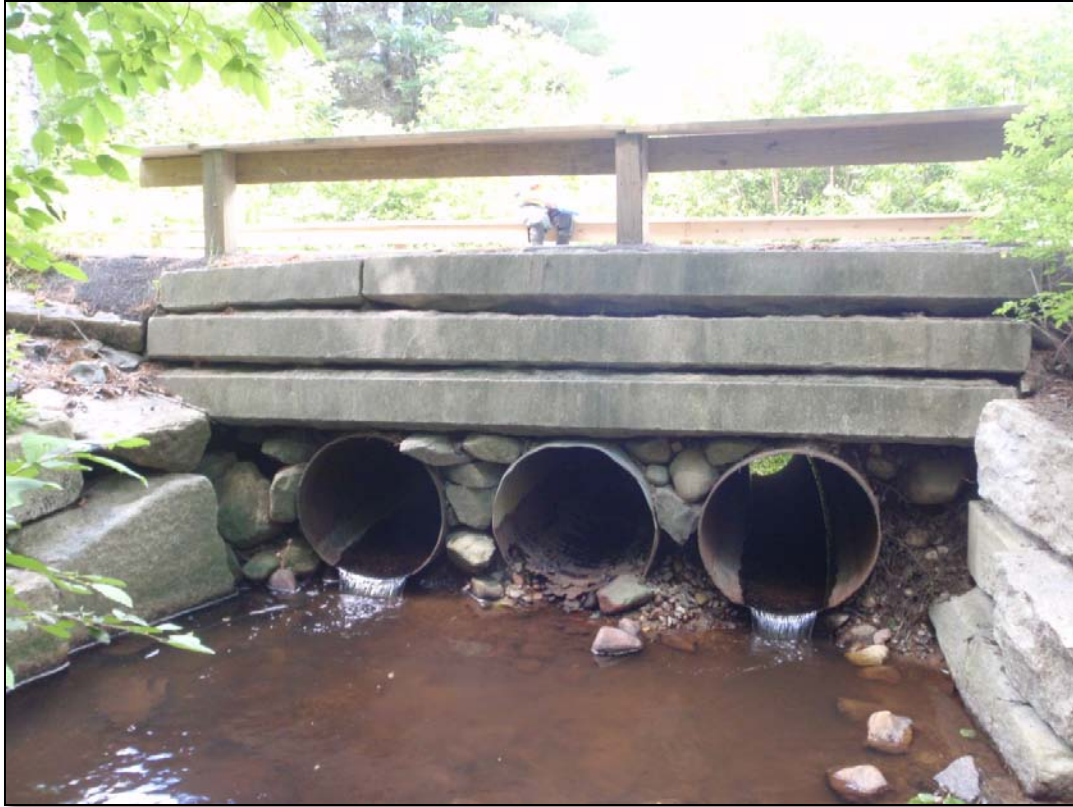
**Private road crossing on an unnamed tributary to Branch Brook. All three culverts at this crossing have perched outlets.**

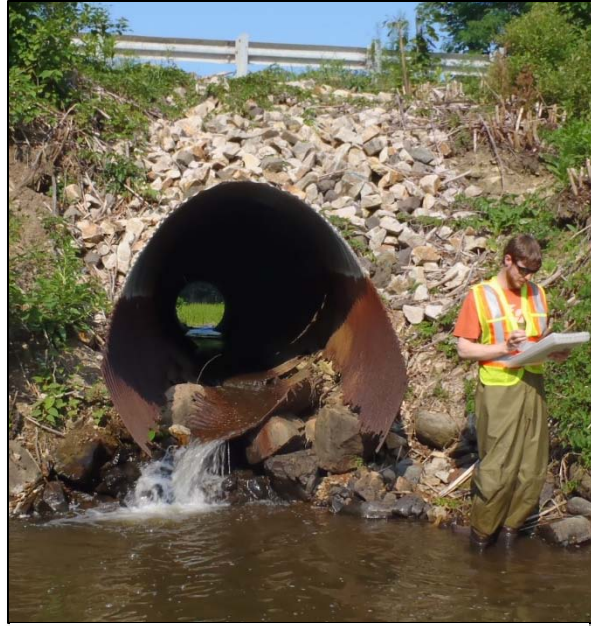
Priority site 11730 in Eliot is a round culvert at the crossing of Route 101 and Shorey's Brook. This crossing is maintained by the Maine Department of Transportation. The structure is a priority for replacement due to several factors. The culvert outlet is perched, and is located near the head of tide. This creates a complete barrier to upstream movement of sea run fish. A perched inlet creates a backwater upstream, and increased water velocity has created a large scour pool. A recent downstream dam removal has enabled sea-run fish such as river herring and rainbow smelt to reach the base of the Route 101 crossing. Removal of this barrier would open up 1.1 miles of stream habitat, which could facilitate the recovery of anadromous rainbow smelt, and other native species. The downstream dam removal has increased the tidal range at the head of tide. Sea level is projected to increase within the lifetime of any replacement structure, and should be considered when designing the next crossing. The culvert is currently failing and is scheduled for replacement by Maine DOT by 2017.

**Failing culvert at the crossing of Route 101 and Shorey's Brook in Eliot.**

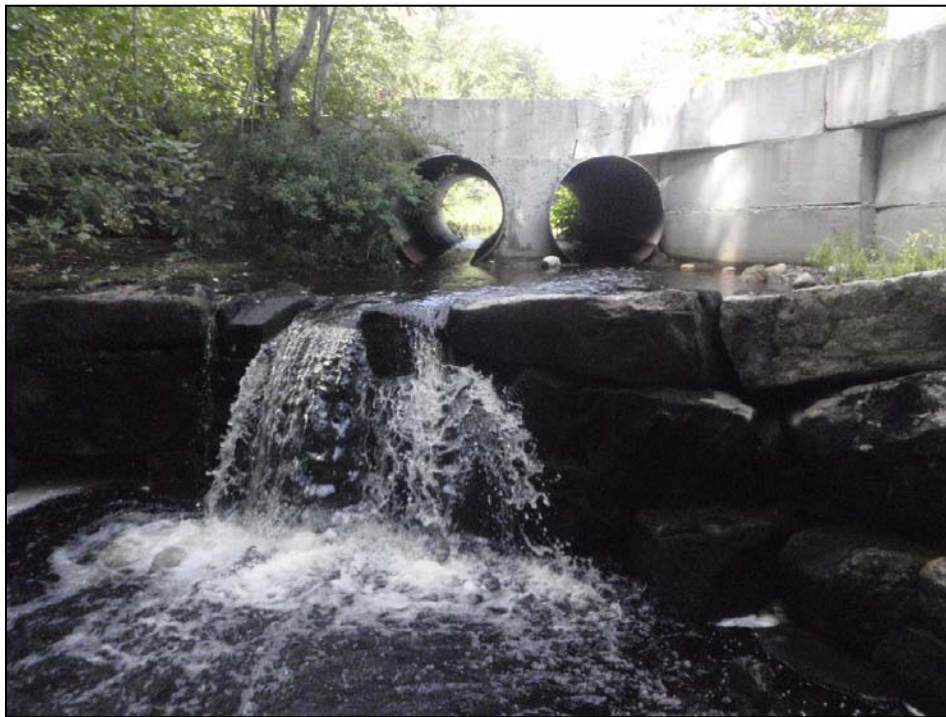
**Spang's Mill Dam and associated private road crossing on the Kennebunk River in Lyman.**
