Kennebunk River Road-Stream Crossing Survey 2010

Prepared by:
Wells National Estuarine Research Reserve
342 Laudholm Farm Road
Wells, Maine 04090

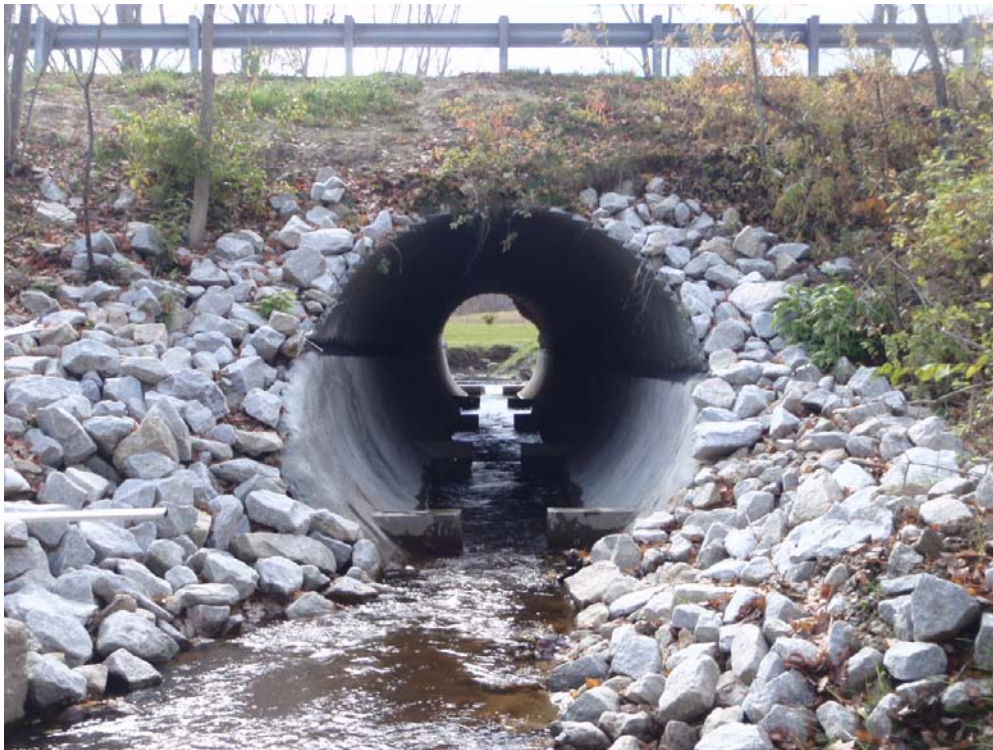
Top: New culvert at the crossing of Lord's Brook and Route 111, in Lyman.

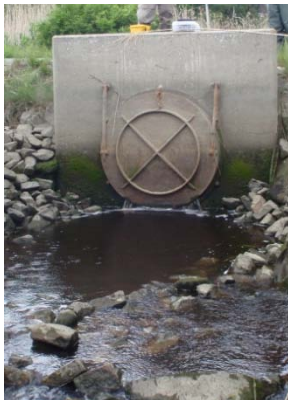
Bottom Left: Tide gate at the outlet of the crossing of a tidal creek and Boothby Road in Kennebunk.

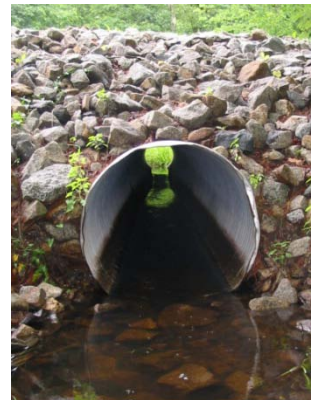
Bottom Right: Outlet of culvert on a tributary of Duck Brook at the Limerick Road crossing in Arundel.

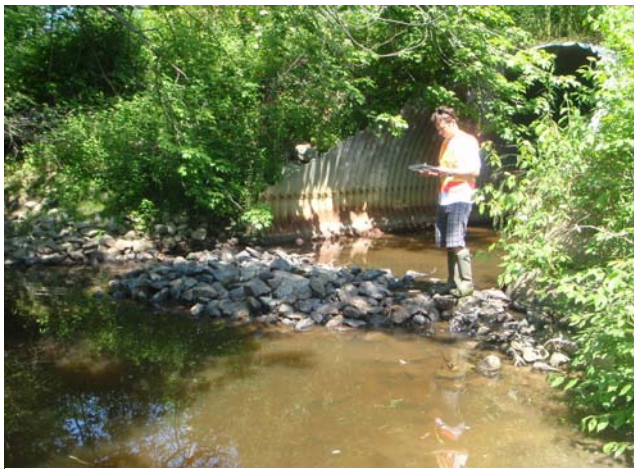
Block outlet at Goff Mill Brook crossing on Sinnott Road in Arundel.

Goff's Mill Brook drains the southeastern portion of the watershed in Arundel and Kennebunkport. A small dam is located just upstream of River Road, before the brook converges with the Kennebunk River. There are two severe barriers on the brook. At the crossing on Sinnott Road a large amount of rip rap blocks the outlet of a pipe arch culvert. Upstream at Whispering Fern Way, the outlet of the box culvert is perched during low water periods. In addition three severe barriers exist at crossings on small tributaries of the brook.

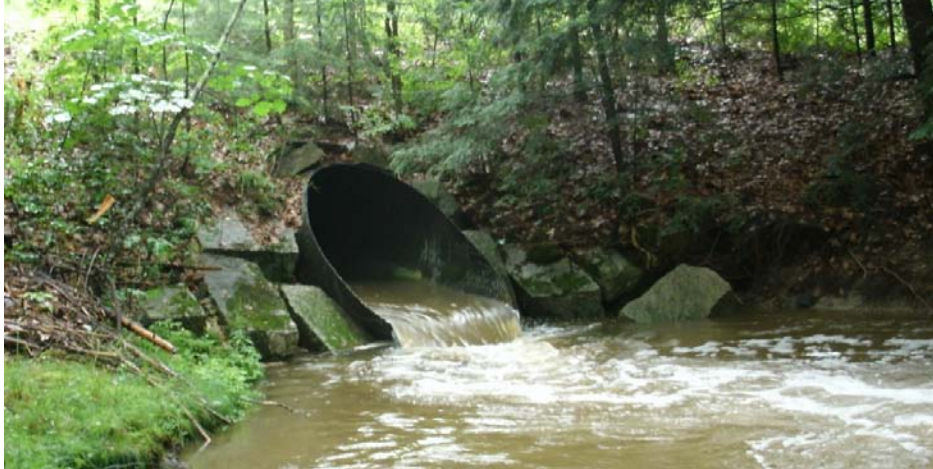
Perched Outlet at Duck Brook crossing on Limerick Road in Arundel.

Duck Brook drains Davis Pond in Arundel and passes through one severe barrier at the crossing on Limerick Road. This site has perched outlet as well as a partial blockage just upstream, where a structure, possibly an old dam, has been breached. Three severe barriers exist at crossings on small tributaries of the brook as well.

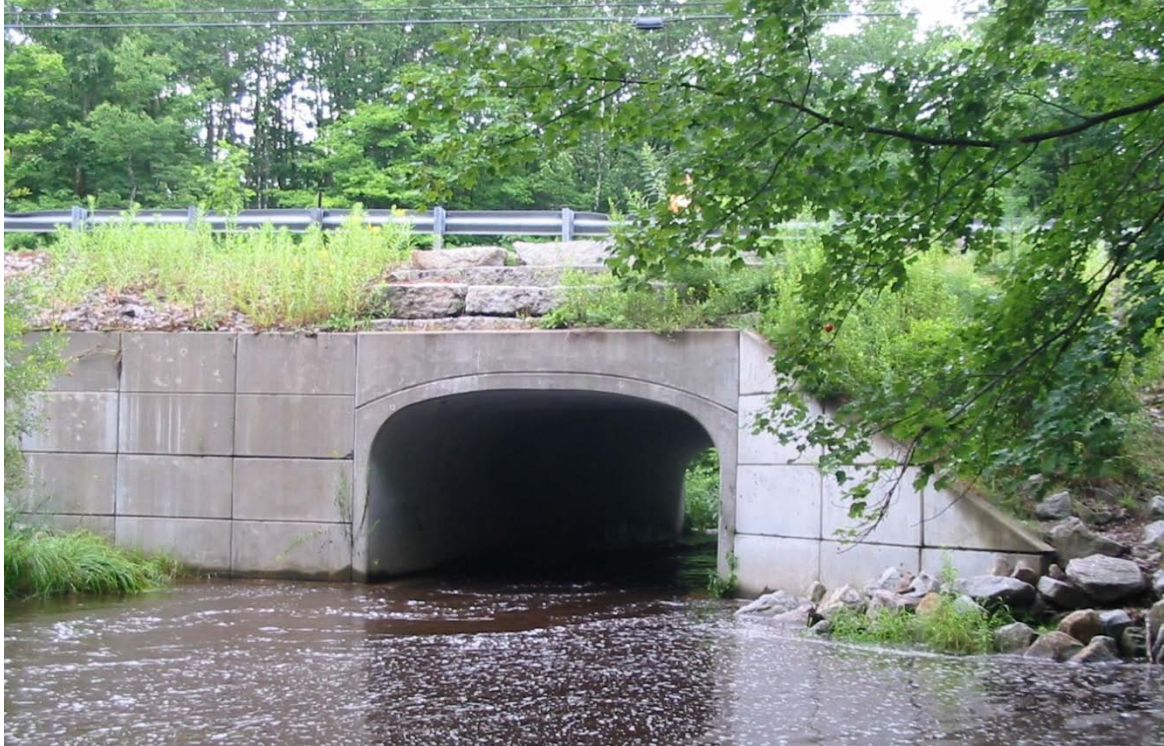
Bridge over Ward Brook on Alewife Road in Kennebunk.

Ward Brook drains Alewife Pond in Kennebunk and does not pass through any severe or moderate barriers at road crossings. There are no man
