# Stream Barrier Inventory

Wells National Estuarine Research Reserve

2013

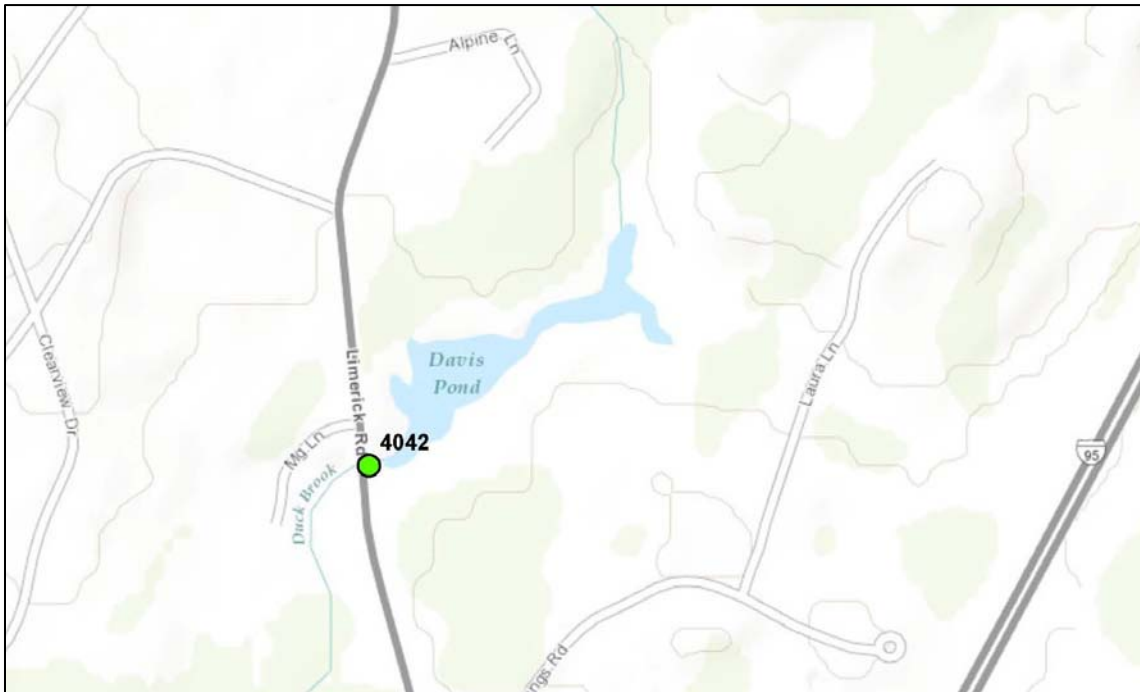
## Limerick Road, Arundel

**Site ID:** 4042  
**Road:** Limerick Road  
**Stream:** Duck Brook  
**Ownership:** Town of Arundel  
**Crossing Structure:** Round Culvert  
**Barrier Status:** Barrier, Perched Outlet

Factors creating a barrier at this crossing include a perched outlet with a 0.13 meter drop, an inlet drop, and increased water velocity due to narrowing of the stream width through the crossing,

This crossing represents the only significant barrier between the Gulf of Maine and Davis Pond (4.3 acres). Ideally, it should be replaced with one that is set below stream grade and exceeds the normal channel width to eliminate the drops and reduce water velocity.

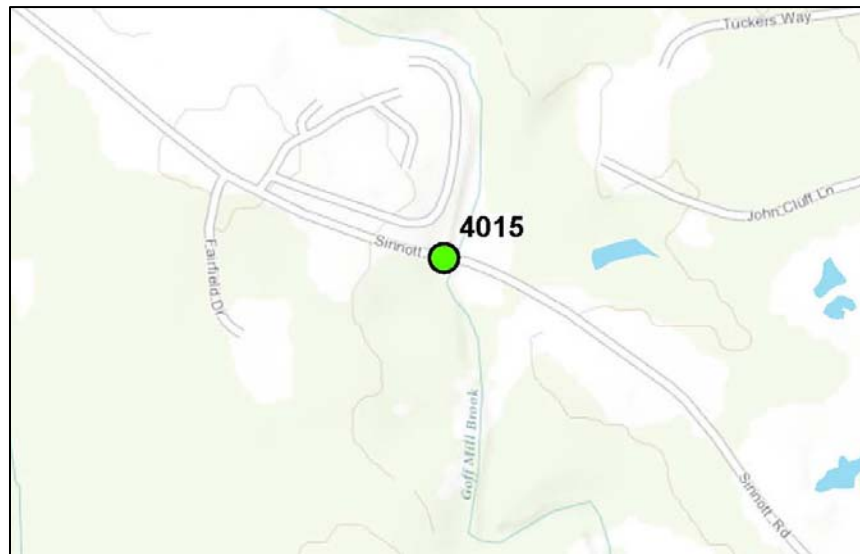
## Sinnott Road, Arundel

**Site ID:** 4015  
**Road:** Sinnott Road  
**Stream:** Goff Mill Brook  
**Ownership:** Town of Arundel  
**Crossing Structure:** Pipe Arch Culve  
**Barrier Status:** Barrier, Perched Outlet, Blocked Outlet

Factors that contribute this barrier include a perched outlet with a 0.1 meter drop, and rip rap partially blocking the outlet.

Rip rap should be removed from the outlet by hand. If replacement of the crossing structure is not feasible, the outlet of the culvert should be modified by bending it if possible to reduce or eliminate the drop.

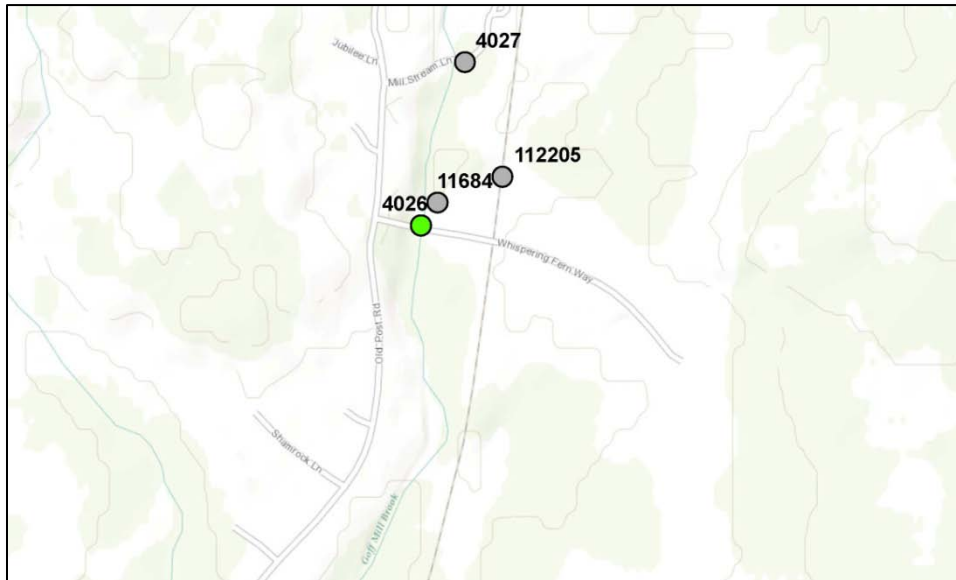
## Whispering Fern Way, Arundel

**Barrier Status:** Barrier, Perched Outlet

Factors that contribute this barrier include a perched outlet with a 0.03 meter drop and increased water velocity due to narrowing of the stream channel through the structure.

The structure should be replaced with one that is set at or below stream grade and exceeds normal channel width to eliminate the drop and decrease water velocity.

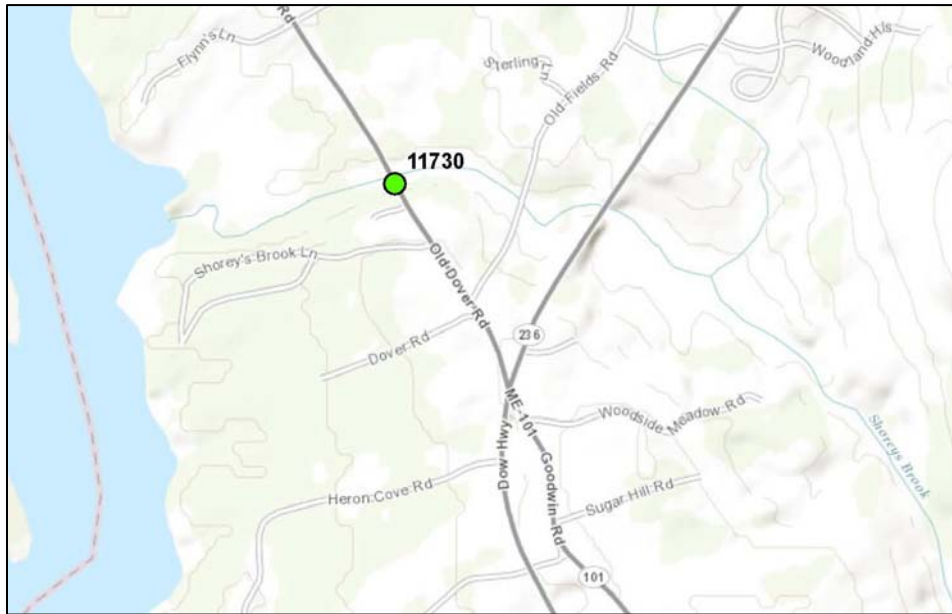
## Route 101, Eliot

**Site ID:** 11730  
**Road:** Route 101  
**Stream:** Shorey's Brook  
**Ownership:** Town of Eliot  
**Crossing Structure:** Pipe Arch Culve  
**Barrier Status:** Barrier, Perched Outlet

Factors that contribute this barrier include a perched outlet with a 0.49 meter drop and increased water velocity due to narrowing of the stream channel through the structure.

Replacement of this crossing is under consideration by Maine DOT due to ongoing failure of the culvert. Ideally, the culvert will be replaced with a bridge, which will eliminate the drop and reduce water velocity.

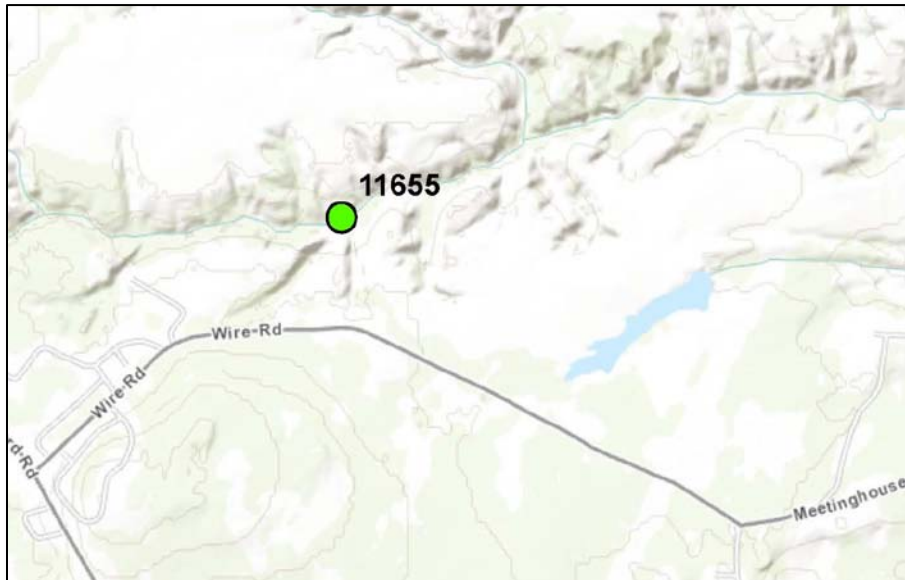
## Abandoned bridge near Wire Road, Kennebunk

**Barrier Status:** Barrier, Blocked

This crossing appears to be an abandoned road or railway near Wire Road. It is located on a parcel owned by the KKW Water District. The stone bridge has partially collapsed and rocks and debris block the entire crossing. The crossing also restricts the channel, which would increase water velocity if the crossing were not also blocked.

This crossing constitutes a significant barrier on the main stem of Branch Brook. Debris and collapsed stones should be removed from the stream channel, and ideally the bridge should be completely or partially removed to restore full channel width and decrease high water velocity.

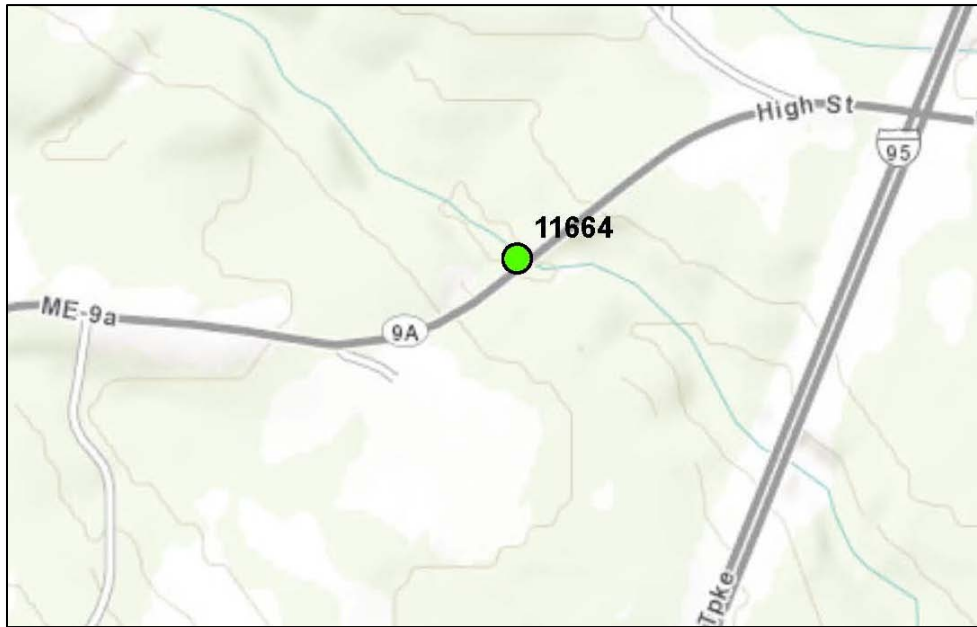
## Route 9A, Kennebunk

**Barrier Status:** Barrier, Perched Outlet

Factors creating a barrier at this crossing include a perched outlet with a 0.27 meter drop and increased water velocity due to narrowing of the stream width through the crossing. This crossing includes a concrete pad at the outlet that creates a perch.

Due to the size and design of this structure, it seems unlikely that it will be replaced. However, modifications could be made to the outlet to eliminate the drop, and interior structures could be installed to reduce water velocity.

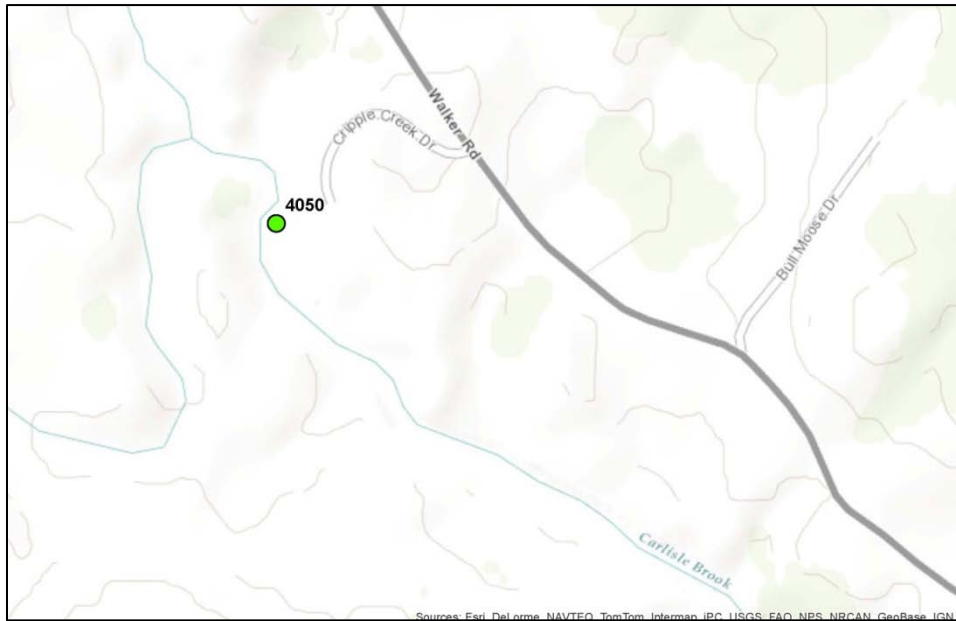
## Cripple Creek Drive, Lyman

**Site ID:** 4050  
**Road:** Cripple Creek Drive  
**Stream:** Carlisle Brook  
**Ownership:** Private  
**Crossing Structure:** Round Culvert  
**Barrier Status:** Barrier, Outlet Perched Above Cascade

Both of these culverts should be replaced with a single structure that is at or below stream grade and exceeds the normal channel width to eliminate the drop and decrease water velocity.

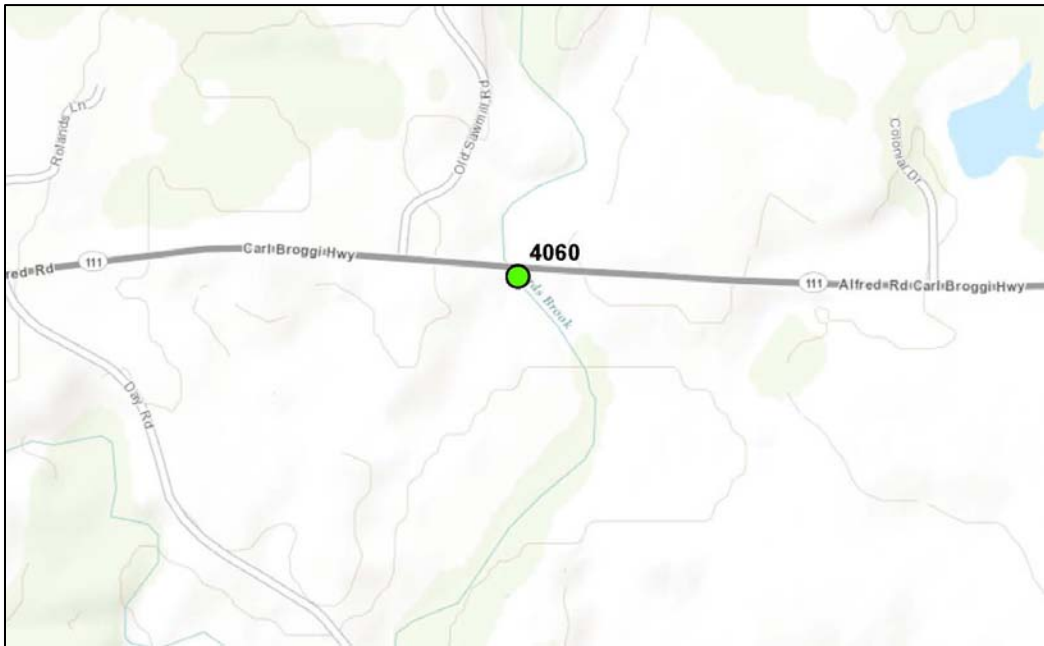
## Route 111, Lyman

**Site ID:** 4060  
**Road:** Route 11  
**Stream:** Lord's Brook  
**Ownership:** Maine DOT  
**Crossing Structure:** Pipe Arch Culvert  
**Barrier Status:** Barrier, Perched Outlet  
**Barrier Description:**

Ideally, this crossing should be replaced with one that is at or below stream grade and exceeds the normal channel width to eliminate the drop and reduce water velocity.

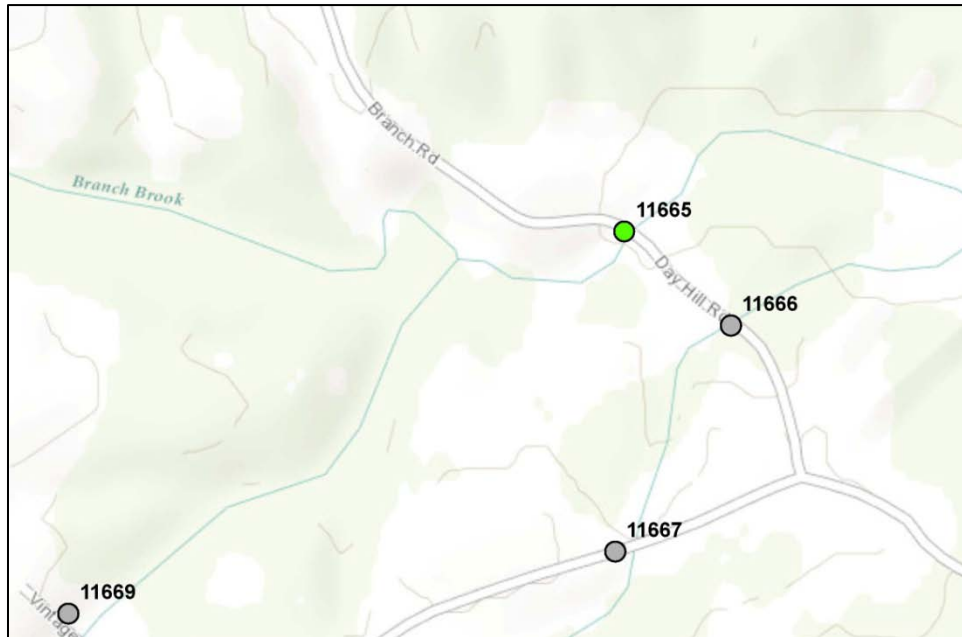
## Day Hill Road, Wells

**Site ID:** 11665  
**Road:** Day Hill Road  
**Stream:** Branch Brook  
**Ownership:** Town of Wells  
**Crossing Structure:** Pipe Arch Culvert  
**Barrier Status:** Barrier, Perched Outlet

This structure should be replaced with one that is at or below stream grade and exceeds the normal channel width to eliminate the drop and decrease water velocity.
